### The Dharan-Dhankuta Road, Koshi Zone: overview of engineering performance and lessons learned during the first 40 years

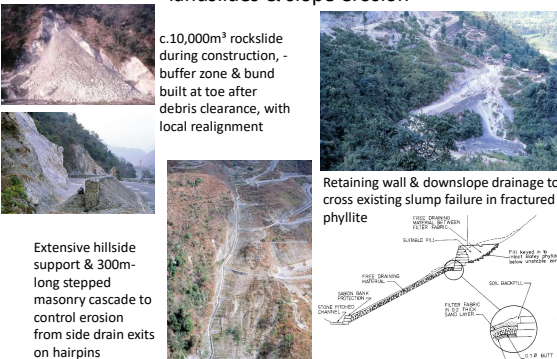
c.10,000m<sup>3</sup> rockslide during construction, - buffer zone & bund built at toe after debris clearance, with local realignment

Extensive hillside support & 300m-long stepped masonry cascade to control erosion from side drain exits on hairpins

Retaining wall & downslope drainage to cross existing slump failure in fractured phyllite

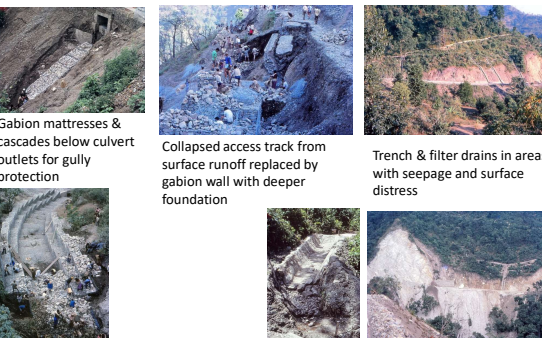
Gabion mattresses & cascades below culvert outlets for gully protection

Collapsed access track from surface runoff replaced by gabion wall with deeper foundation

Trench & filter drains in areas with seepage and surface distress

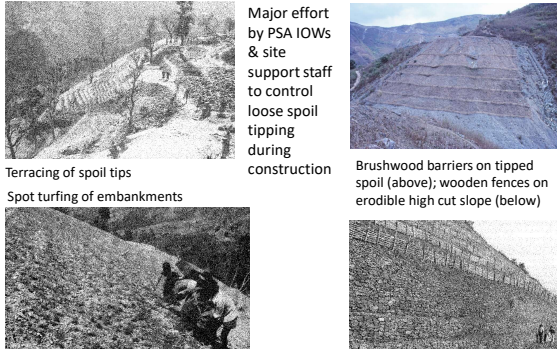
Major effort by PSA IOWs & site support staff to control loose spoil tipping during construction

Terracing of spoil tips

Spot turfing of embankments

Brushwood barriers on tipped spoil (above); wooden fences on erodible high cut slope (below)
