Nepal Engineers' Association

TECHNICAL JOURNAL

Special Issue on Gorkha Earthquake 2015

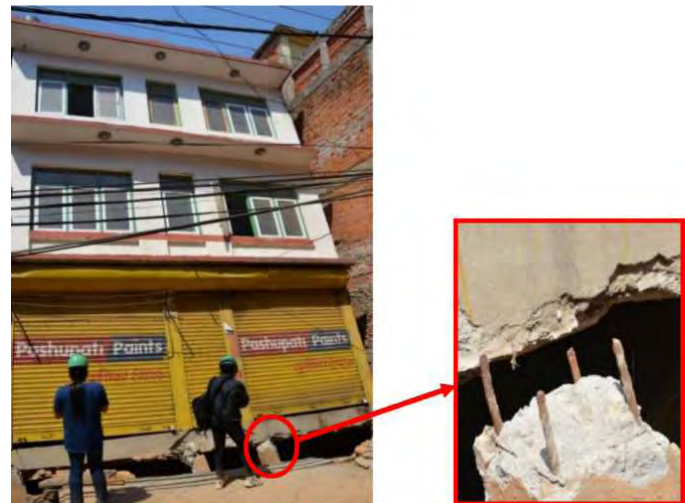
Photo 4: Collapse of a 3 storied RC (poor ductile detailing) Building

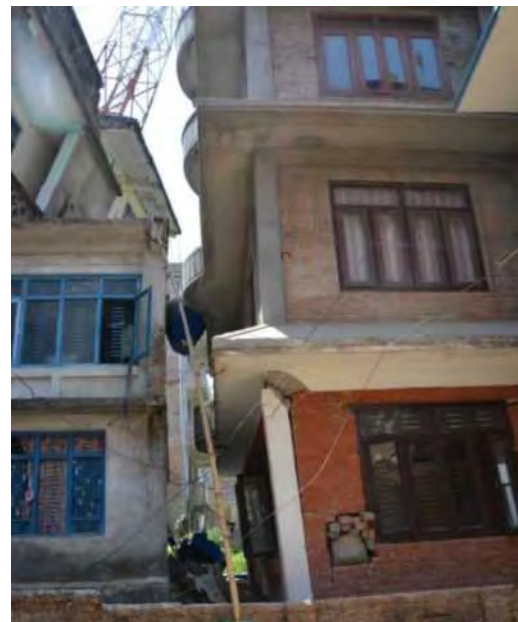
Photo 5: Damage to the first story of the 3 storied building

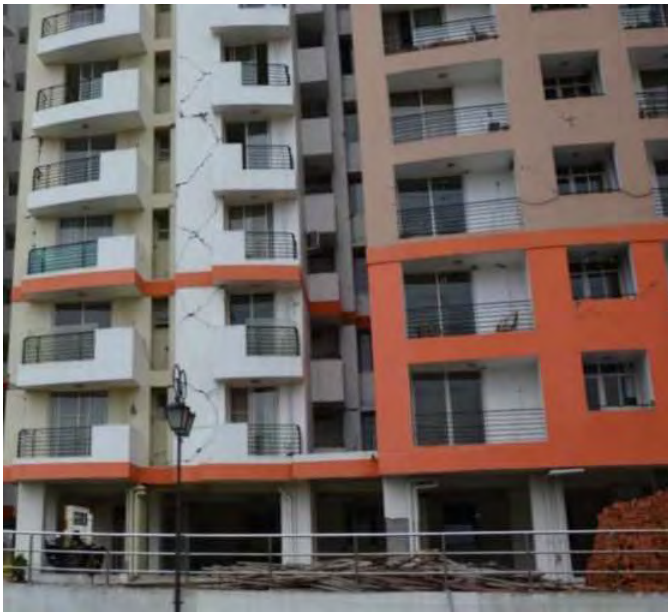
Photo 8: Diagonal cracks in the masonry infill walls

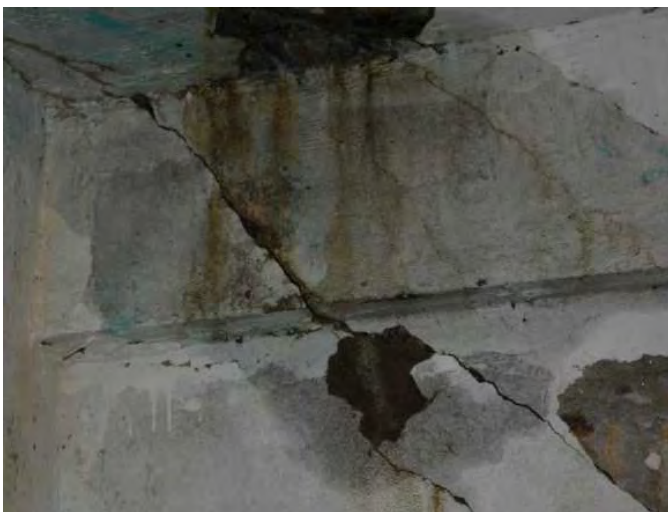
Photo 9: Diagonal shear failure of a beam

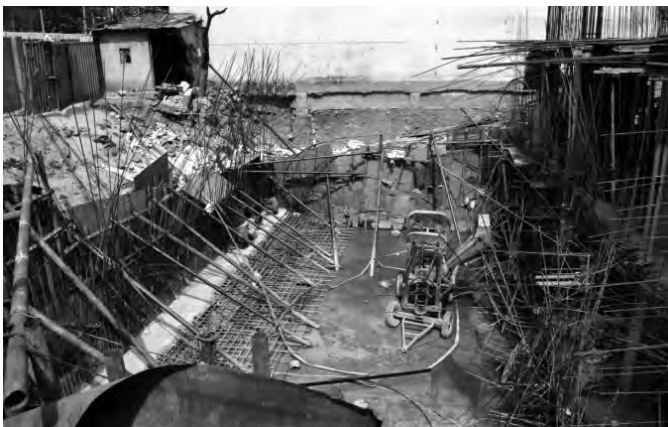
a) Northward view of the coseismic shoring failure at Kamaladi

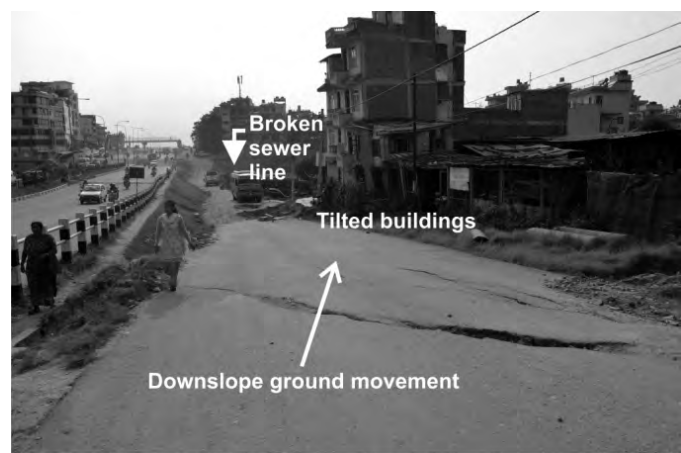
a) Westward view towards the Manohara river at Lokanthali ground failure site

Figure 7. Downslope ground deformation, building damage and sewer line break at Lokanthali

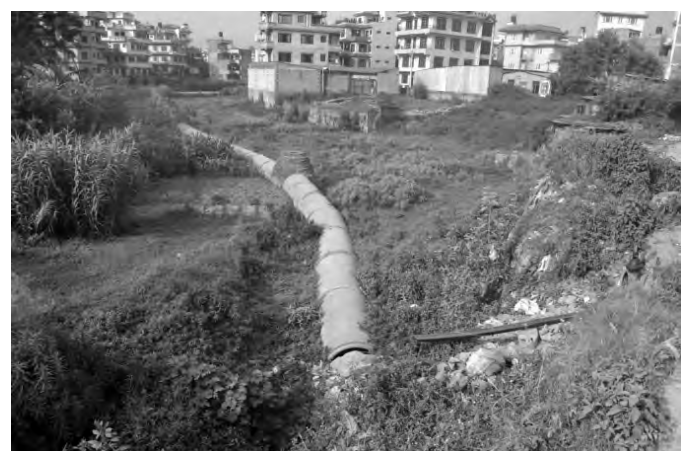
b) Northward view of the broken sewer line along the Manohara

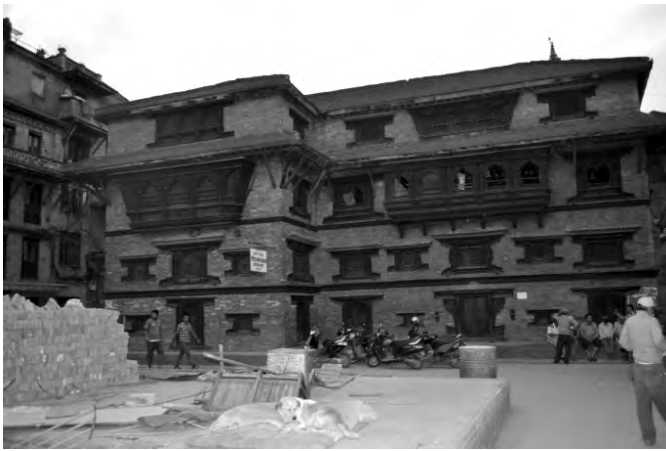
a) Undamaged masonry confined within timber straps, Chamyasingh

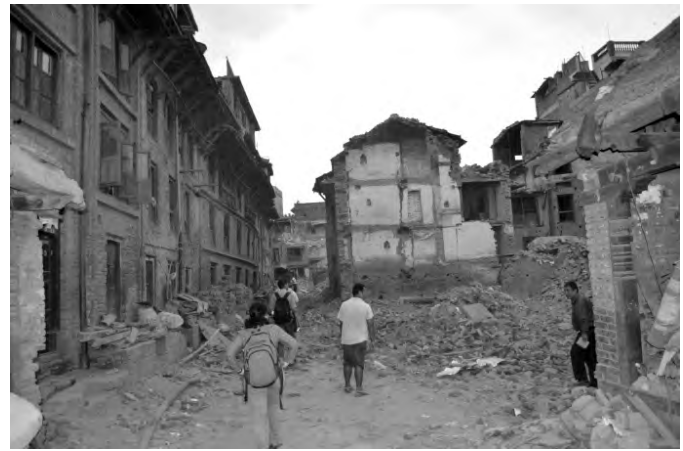
b) Damaged masonry buildings of Chamyasingh

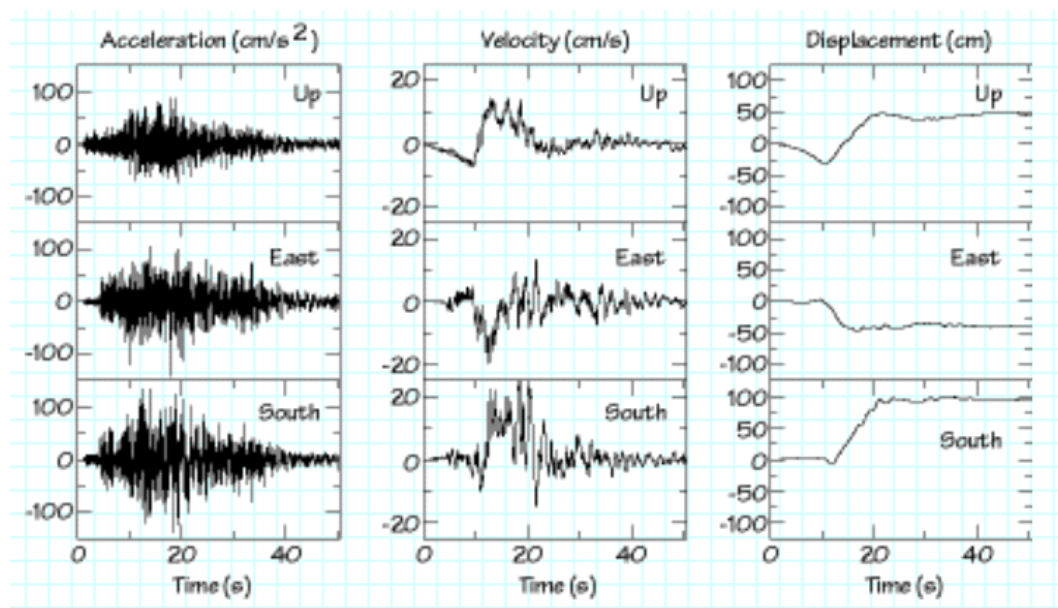
Figure 4. Strong motion record from the 1985 $M_w=7.6$ Michoacan earthquake with >6 m of slip, showing acceleration, velocity and displacement ≈ 20 km above the rupture.

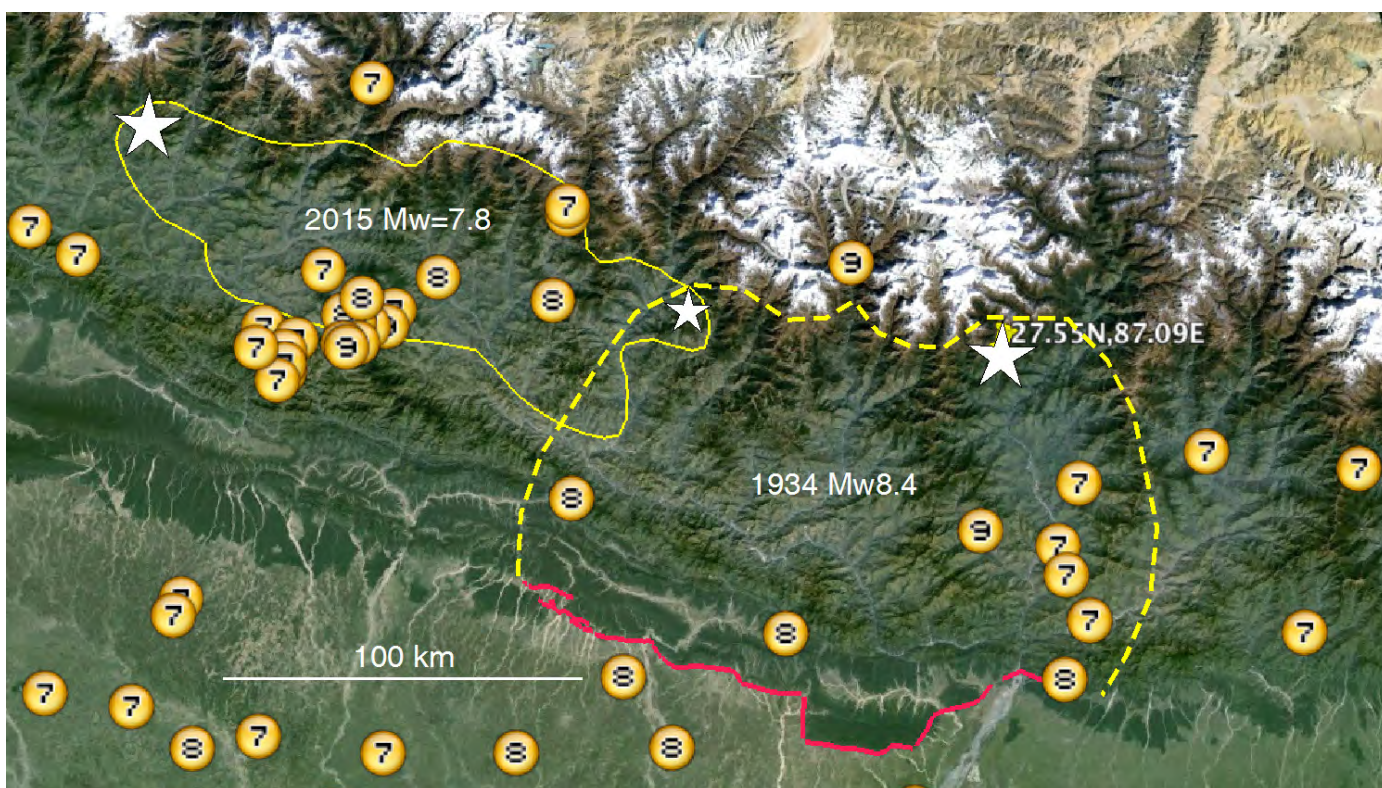
Figure 7 Reported EMS intensities for the Nepal 1934 $M_w=8.4$ earthquake (Martin and Szeliga, 2004) with a conjectural rupture zone (dashed). Epicenter is from Chen and Molnar (1987) and MFT rupture from Sapkota et al., 2012. Intensities above the 1934 rupture are sparse but average $EMS\ 7.6 \pm 0.7$. With the conjectural rupture shown, mean slip in 1934 would be $\approx 8\text{ m}$.

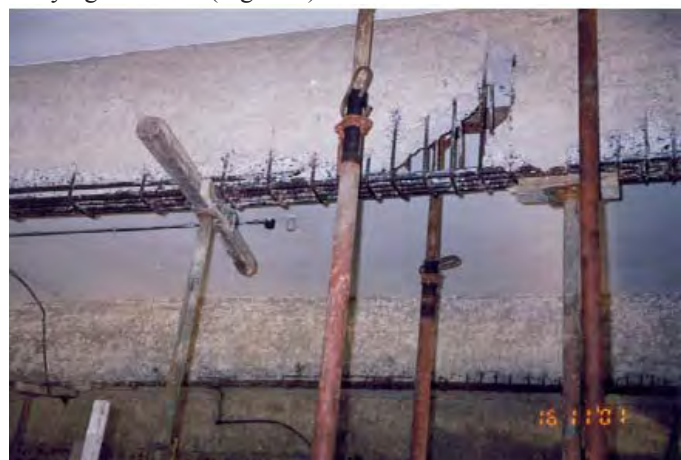
The structural members should be properly supported before chipping the spalled / loose concrete. The props provided shall be adequate to provide sufficient structural support to the load carrying members (Figure 6).

Figure 6. Props for micro concrete

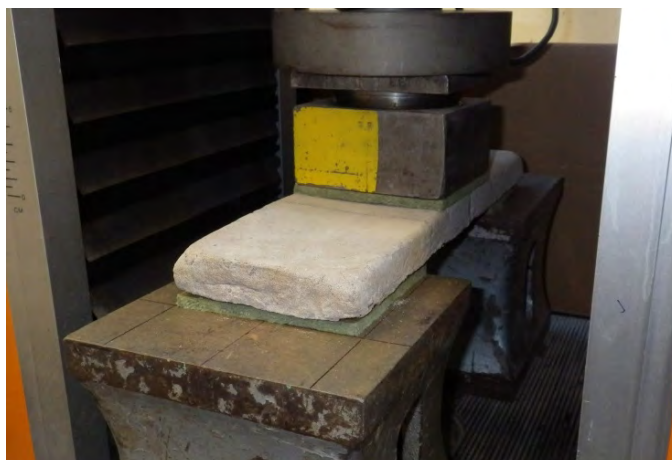
Figure 1. Test set-up
Figure 1. Photograph of testing apparatus:
Source Oxford Brookes University Laboratory

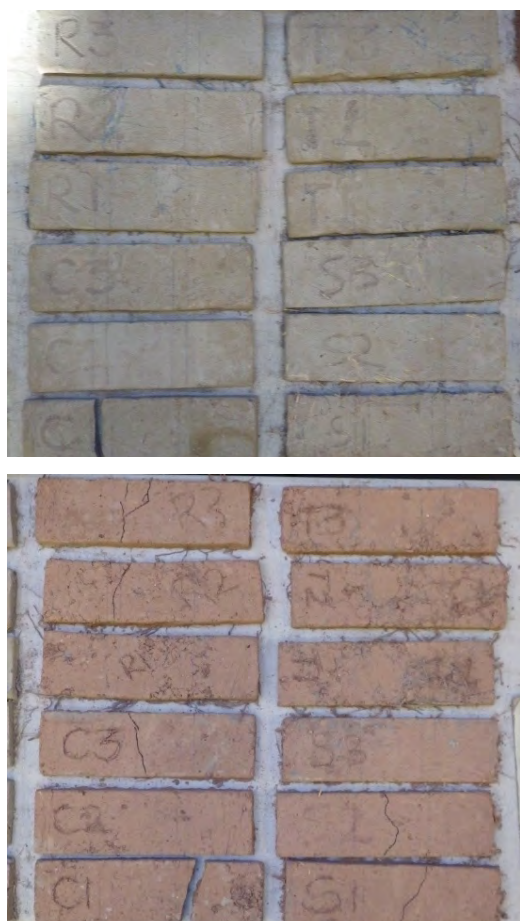
Figure 2. Photograph of Initial condition of samples prior to testing. Source Oxford Brookes University Laboratory

It is apparent that the earth mortar specimens were in noticeably worse condition than the normal mortar.

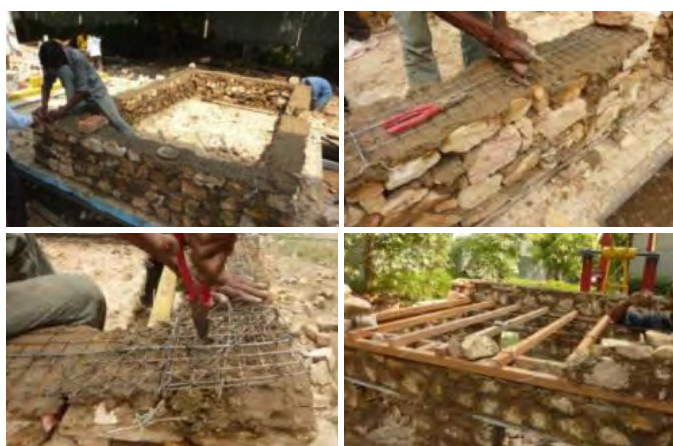
Fig 4 – Construction sequence of 1^{1/2} story model

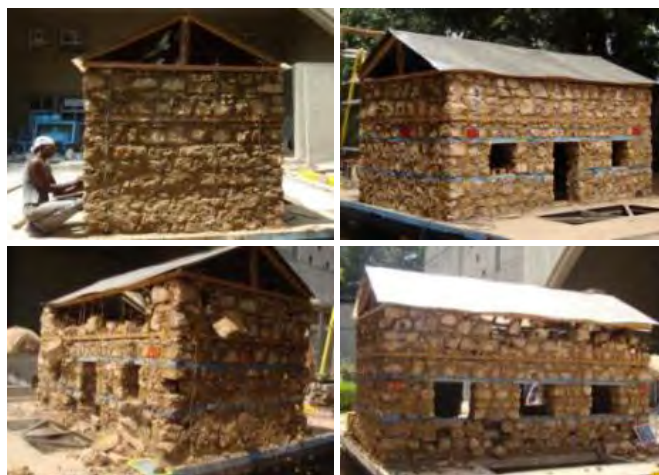
Fig 5 – 1^{1/2} story model - post test condition

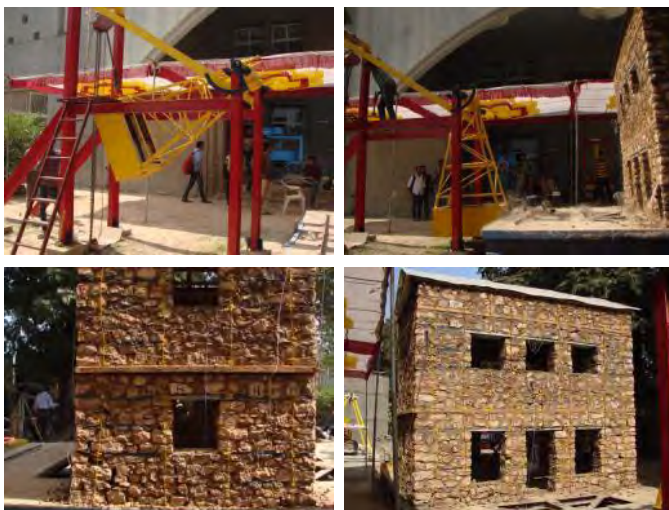
Fig 7 – Impact 14 - Pendulum at 67° inclination; Mortar and stones etc. falling at impact; Diagonal crack at NW base; Stone chips and mud mortar fallen out near S side base

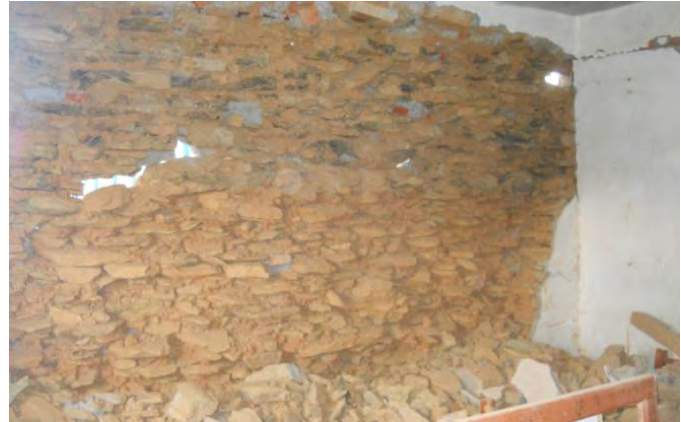
a) Delamination of stone masonry infill wall in a RC frame building.

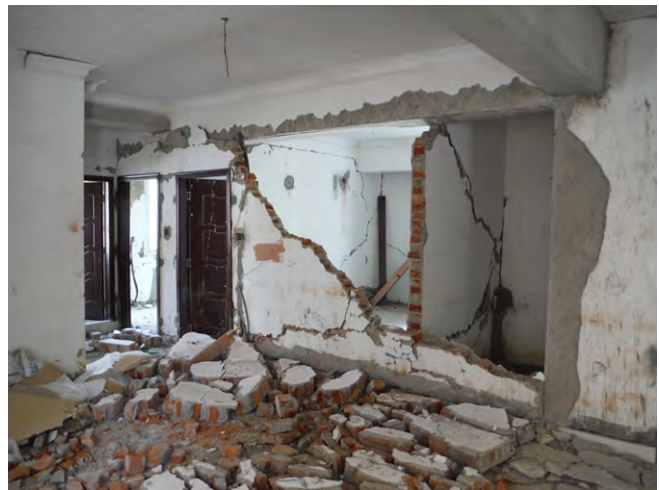
h) Diagonal tension failure and toppling of partition walls in a multi-storey RC frame building.

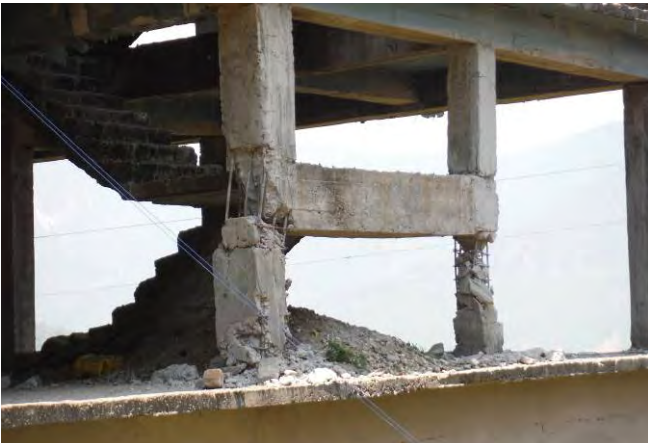
e) A damaged RC frame building (note lack of stirrups in the joint)

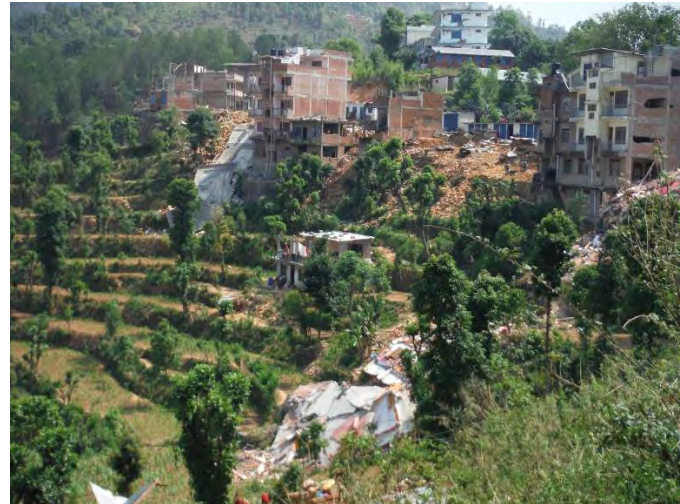
Figure 8: Destruction of buildings on steeply sloping ground.

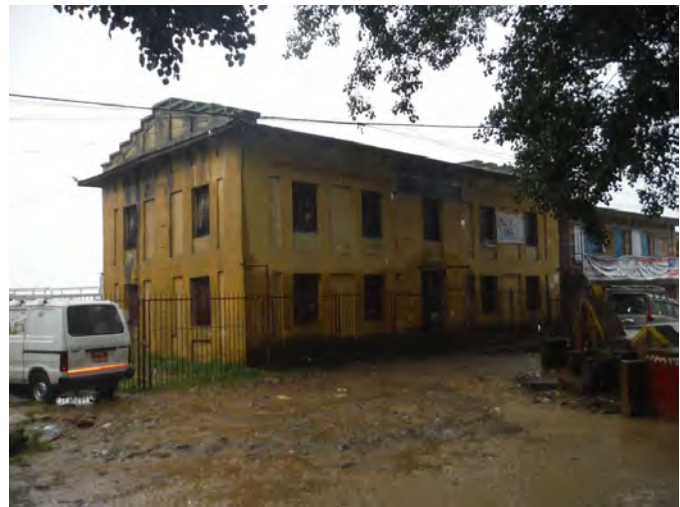
Figure 11: A strengthened brick masonry building in mud mortar (Kathmandu valley), the building survived without any damage.
